Geoelectric Imaging for Foundation Failure Investigation AT Olabisi Onabanjo University (O.O.U) Minicampus, Ago Iwoye, southwestern Nigeria.

Abstract: An investigation of the cause (s) of the foundation failure of the PDS building in the Mini-Campus of Olabisi Onabanjo University, Ago Iwoye Nigeria was carried out using the electrical resistivity method. The aim was to delineate the subsurface as a means of determining the cause (s) of the foundation failure. Measurement involving Dipole-Dipole configuration and vertical electrical sounding (VES) were taken along four (4) traverses, using the Pasi Earth (16GL) Resistivity meter. The results were presented as a pseudosection, 2-D resistivity map and geoelectric sections. Three geoelectric layers were delineated from the results; these are the top soil (sandy clay), weathered layer (clayey sand) and fresh basement. The pseudosection and resistivity map suggest that clayey material constitute some part of the subsoil materials. It is concluded from these that the building failed due to incompetent clay layer and improper foundation design on some side of the building on which the building was founded.

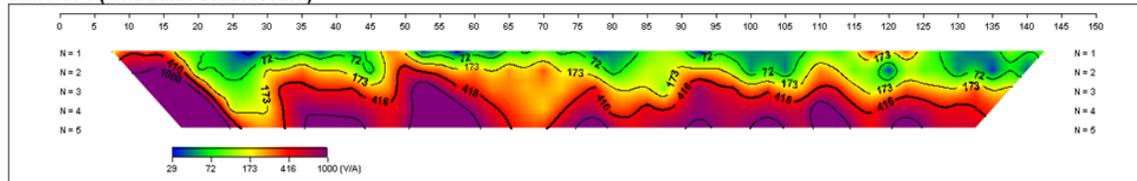
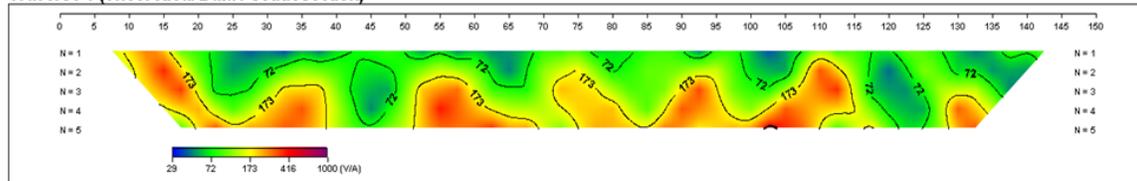
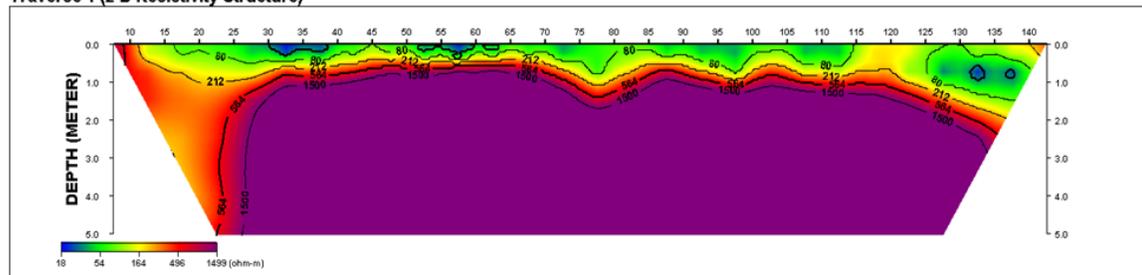
Traverse 1: The direction of the traverse goes from E-W, the lateral extent of the traverse is 150m.

The pseudosection and 2-D resistivity map were qualitatively interpreted revealed three geoelectric layers, which are top soil, (which contain pocket of clay), weathered bedrock and the fresh basement respectively.

From the field data pseudosection, theoretical data pseudosection and 2D resistivity structure along TR1 shows that it is relatively stable for foundation structure, because the weathered basement has moderate resistivity and the basement is close to the surface. The only structure observed along this traverse is at distance position 60-75m, which is a highly weathered structure that is outside the building area.

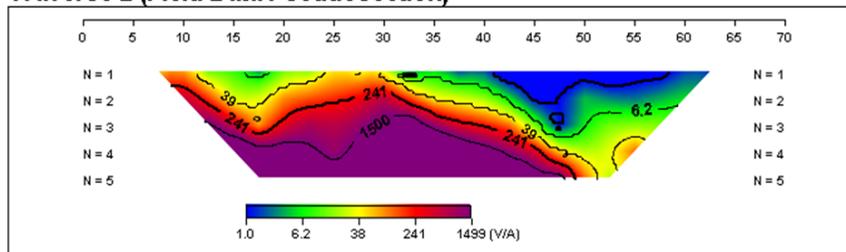
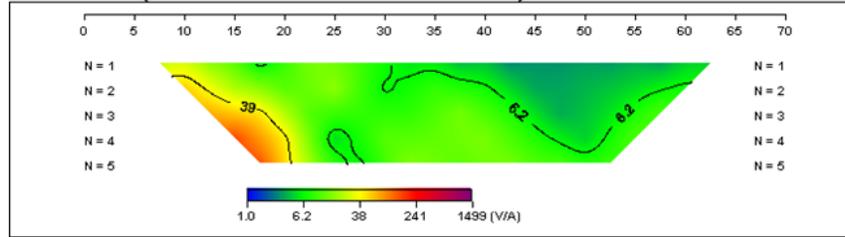
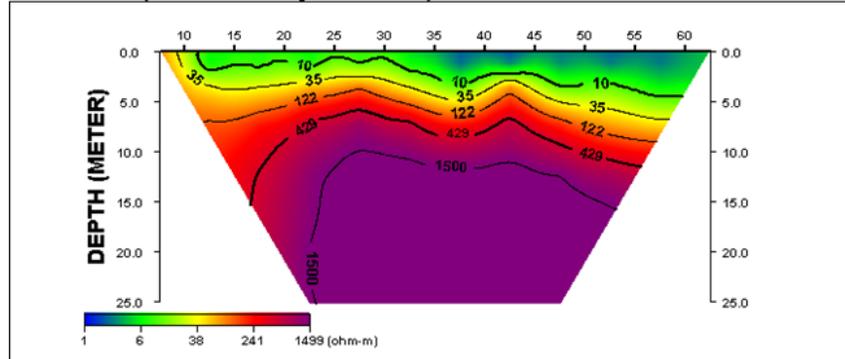
Traverse 2: This traverse goes in the N-S direction with a lateral extent of 65m, the pseudosection and 2-D resistivity map delineate three geoelectric layers which are the top soil (clay/sand), weathered basement and fresh bedrock.

At the beginning of this traverse, from distance position 0-35m, the overburden is competent which is a weathered basement due to its high resistivity. Toward the ending of this traverse, it has a very low resistivity which is diagnostic of clayey weathered material which is not a good foundation materials, it has a resistivity value less than 50Ωm. This may have been the cause of the foundation subsidence, which has been observed in this part of the building due to cracks on the walls. The weathered clayey material is up to the depth of 4m.

The 2.D resistivity structure has also confirm this by showing a low resistivity material to a depth of about 4m toward the back of this building, whereas at the front, this incompetent weathered clayey material is very close to the surface.

In the light of this result, it is observed that the failure of the foundation is due to differential settlement toward the end of traverse 2 which is pronounced by the observed tilting and cracks. Due to the treat of the tilting and cracks observed on this building which result from differential settlement, it is advised that reinforcement and concrete packing should be done in areas with more pronounced subsidence so as to avert further damage and total collapse. Buttress pillar will also go a long way to rescue the building from further differential settlement and total collapse

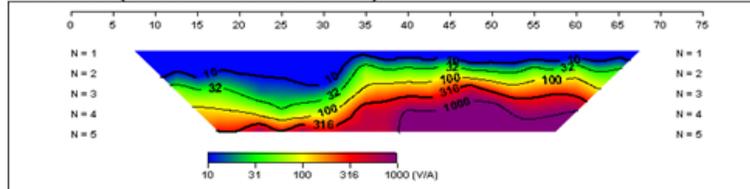
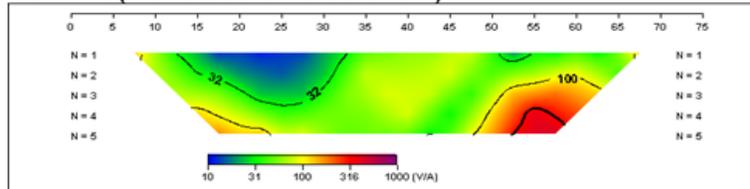
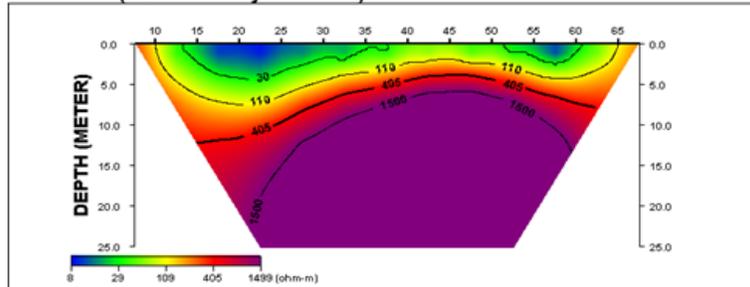
Traverse 3: The direction of the traverse is to the N-S, and the lateral extent is 65m, the pseudosection and 2-D resistivity map delineate three geoelectric layers which are the top soil (sandy clayey), weathered basement and the fresh bedrock.

Much failure are not observed in this side of the building. It has a low resistivity at distance position 10-35m, with resistivity value less than 20Ωm and it is incompetent for a foundation structure, but much failure are not observed because foundation design has taken care of this. The loose clayey material is up to the depth of 3m

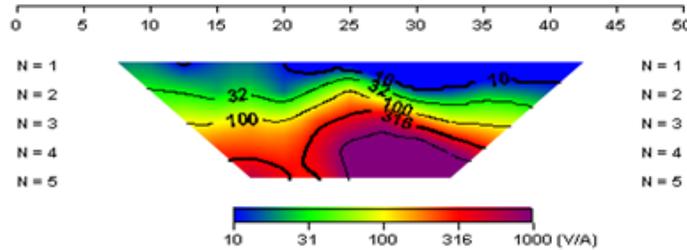
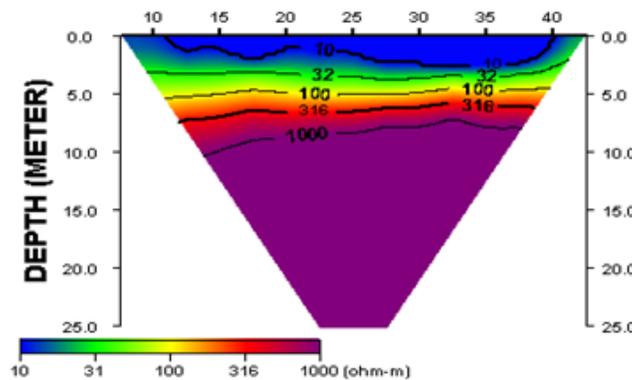
Traverse 4: The direction of this traverse is E-W and the lateral extent of 45m. the pseudosection and 2-D resistivity map delineate three geoelectric layers which consist of the top soil (sandy clay), weathered basement and fresh basement.

It has a low resistivity weathered material to the depth of 3m along this traverse, but with little failure observed. This resistivity value ranges from 10Ωm-15Ωm. The foundation design has taken care of the possible failure in this side. The clay distress of the foundation here might appear less severe most likely because the thick clay layer is uniform along the traverse and causing uniform settlement

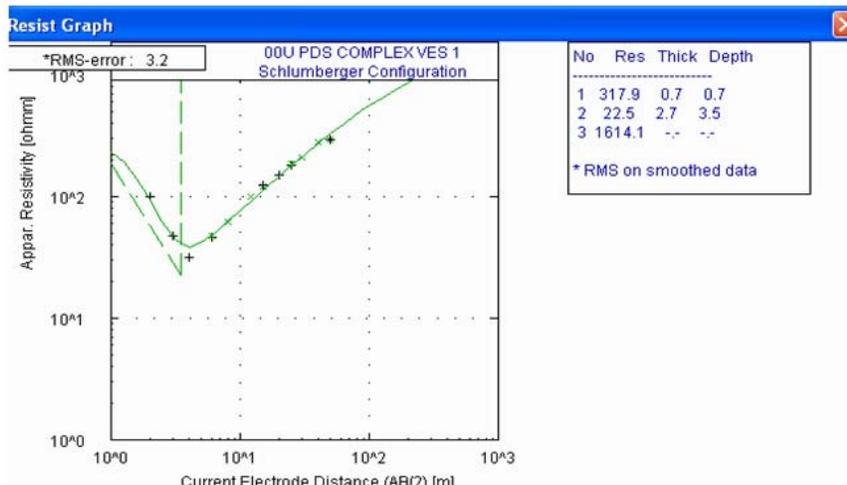
Fig. 5(I): the Schlumberger Depth Sounding Curve Beneath Ves 1 at Oou, Pds Complex

The result of the VES reveals the vertical information of the geologic layers to the depth of about 10m.Three main geoelectric layers were identified: top soil (sand/sandy clay), weathered basement and fresh basement (see fig:5 I- IV) .The weathered basement (clay), which constitutes the second layer has thickness of about 2.7m at VES1 location and overlain by thin sand layer of resistivity value of 318 ohms-m and thickness of 0.7m.This layer is sandy clay/sand in other VES locations. The manifested failure is pronounced at the VES1 location, which we presume that is due to this thick incompetent layer.

The VES interpretation reveals that the area is underlain by three major geoelectric layers, the top soil (sand/sandy clay), weathered basement and fresh basement. At VES 1 location (i.e. end of traverse 2), the weathered layer is made up of clay formation with resistivity value of 23ohm-m to the depth of about 4m. The building failure is more pronounced at this location. Although incompetent clay layer were seen along other traverses but foundation design has taken care of this.
